# Chugach transmission line photographic database project

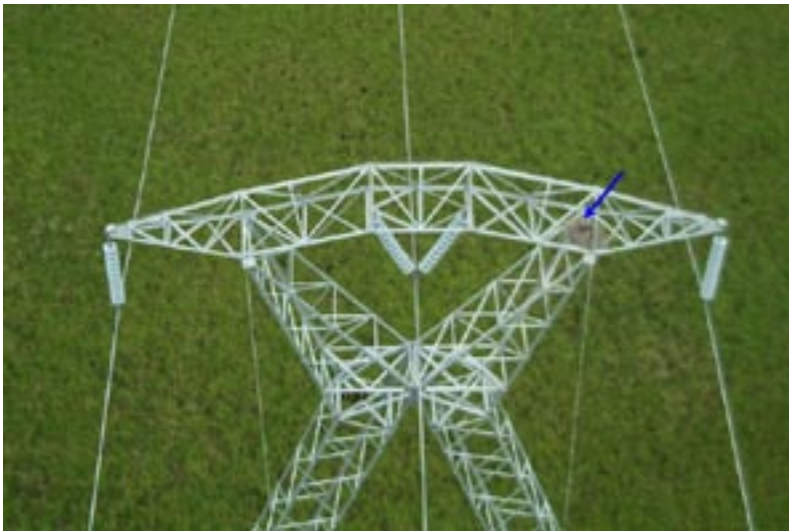
Left: This is a view of the top section of a typical aluminum lattice tower on one of Chugach's three Beluga-to-Point MacKenzie high-voltage transmission lines. Take note of the bird's nest in the upper right hand part of the structure. Bird nests are removed annually after the nesting season by permit from the U.S. Fish and Wildlife Service during our annual winter maintenance. Because of the large amount of wetlands and streams, and helicopter-only access in the summer, maintenance on these lines is normally completed during the winter. Emergency maintenance is done as soon as possible after problems are discovered.

Right: This photo shows the V-string conductor attachment device with one cotter pin missing from the conductor shoe and one cotter pin backing out on the yoke plate that ties the string of insulators together. When any of the pins on the device back out there is a chance that the conductor will drop off the tower.

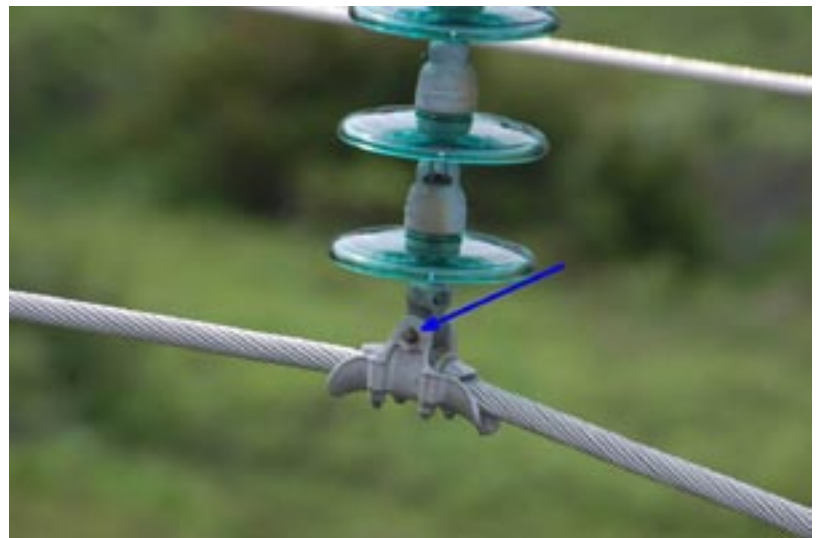
Above: The cotter pin is bent and the conductor pin has backed out to a point where it may not support the weight of the wire much longer.

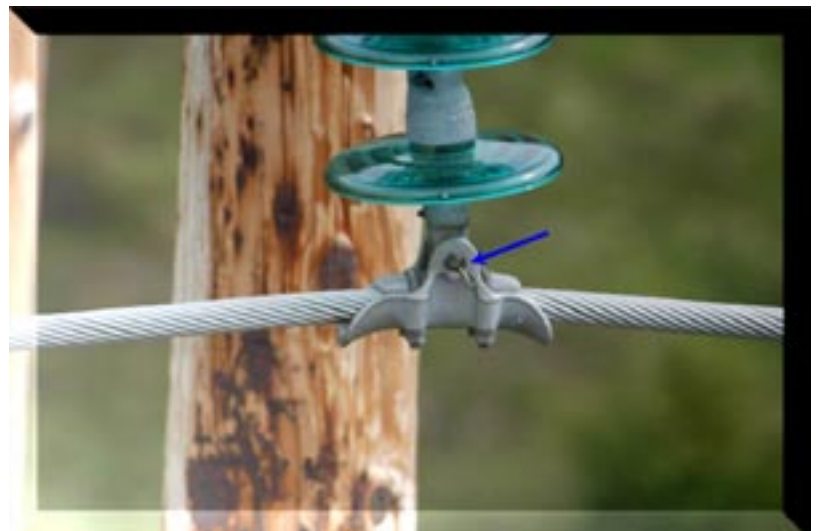
Below: This is a conductor attachment on an insulator string on the Quartz Creek 115-kilovolt line. The photo shows that the cotter pin that keeps the conductor pin from backing out due to vibration is in the process of backing out. This can happen over a long period of time and go unnoticed.
