Alaska Intertie

UNBALANCED SNOW LOADING

Snow Load Monitoring System

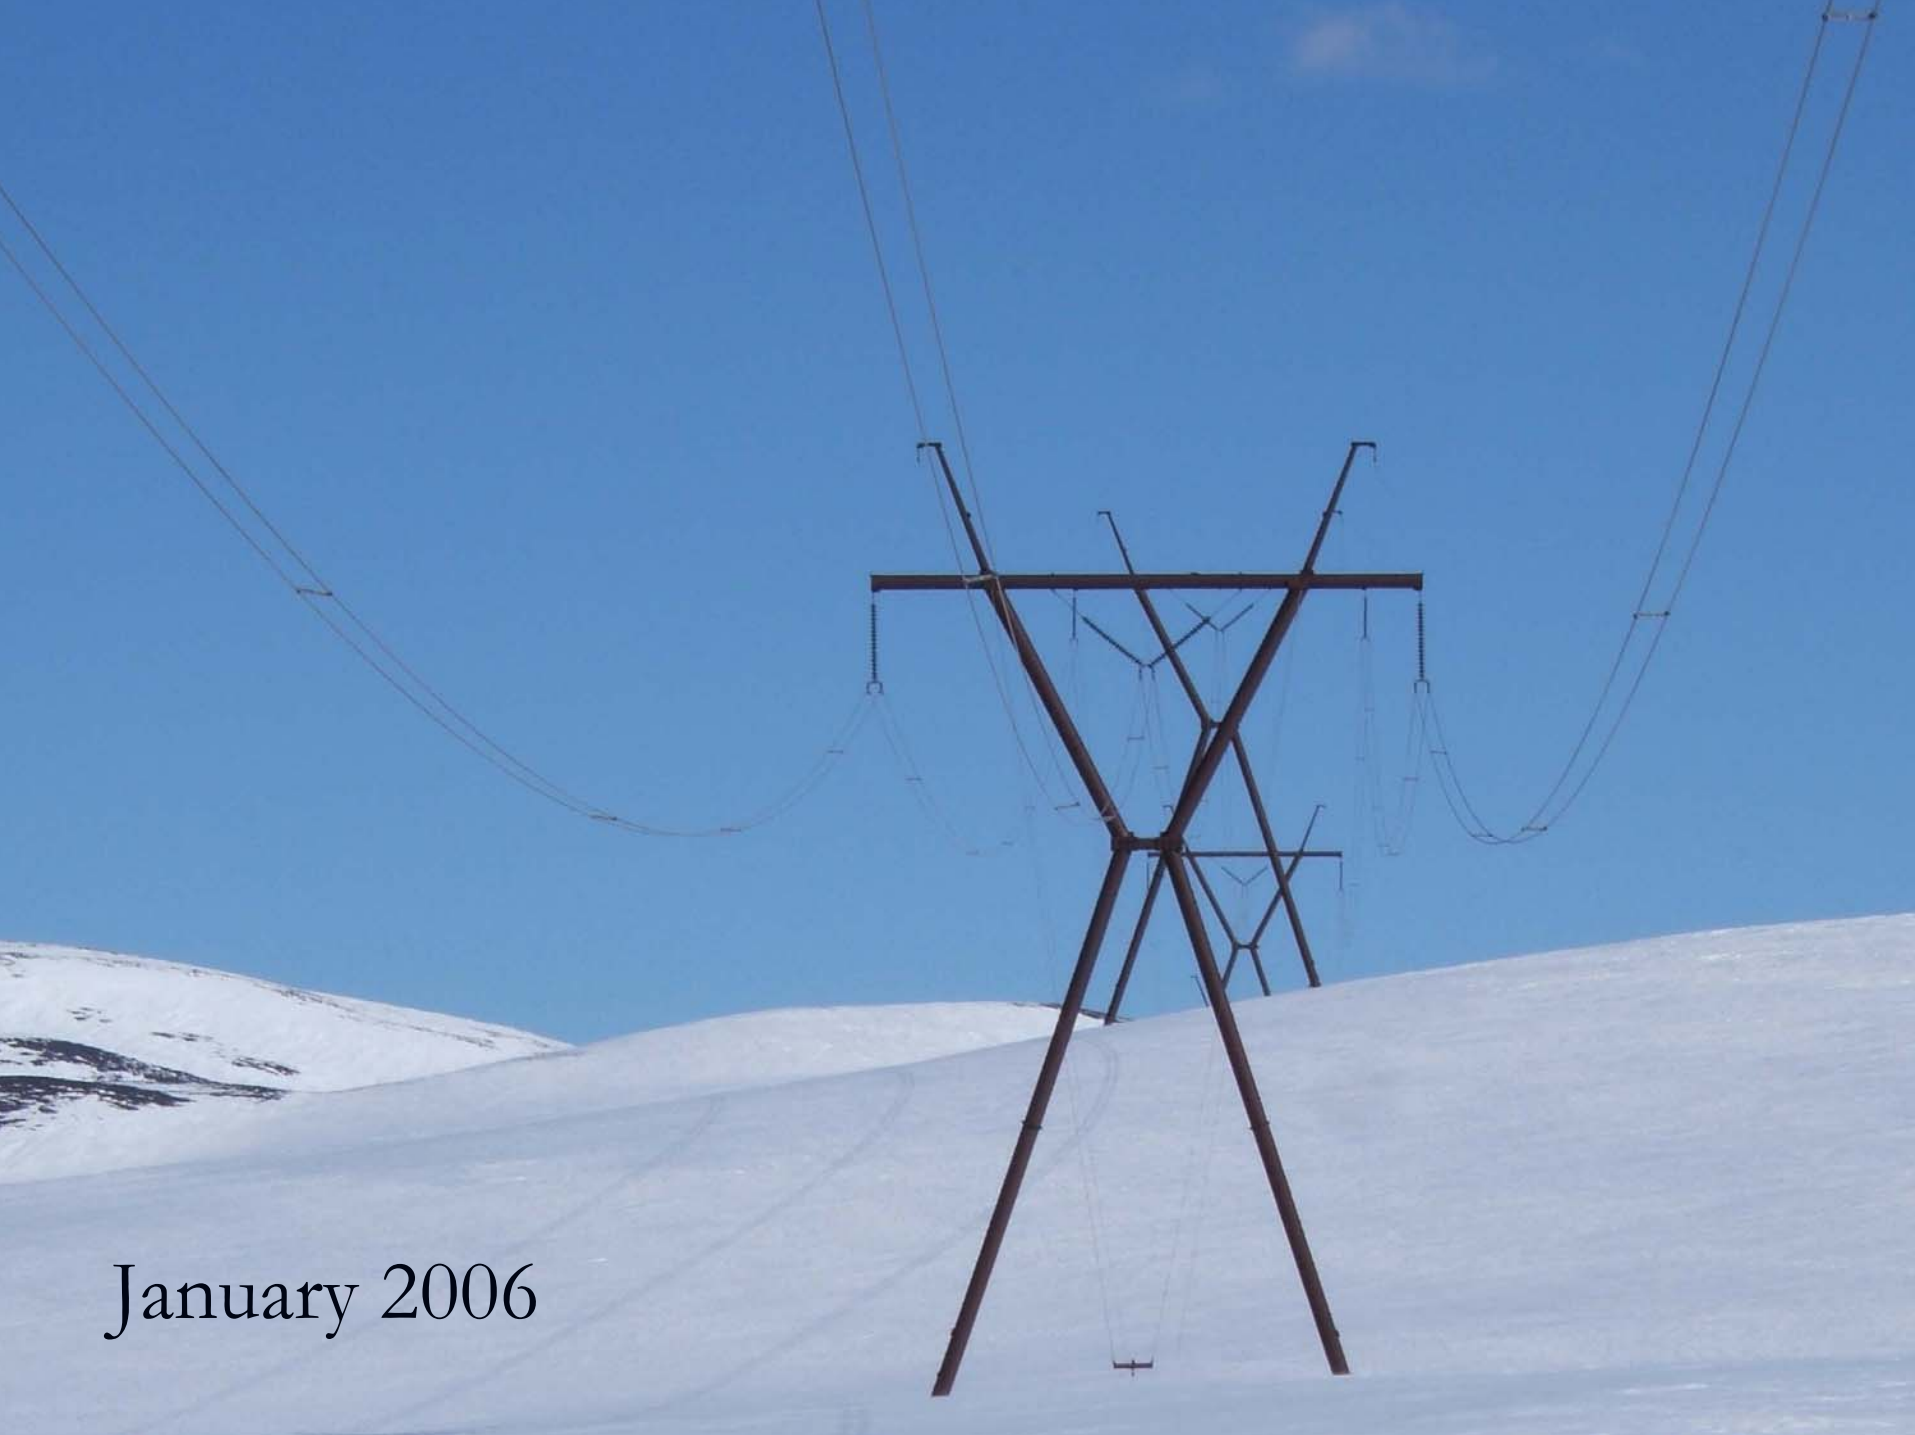
Alaska Intertie Ownership by Line section

Framed and Operated at 230 kV

Framed and Operated at 115 kV

Framed and Operated at 138 kV

Framed at 230 kV Operated at 138 kV

New Construction Framed at 230 kV Operated at 138 kV

Framed at 345 kV Operated at 138 kV

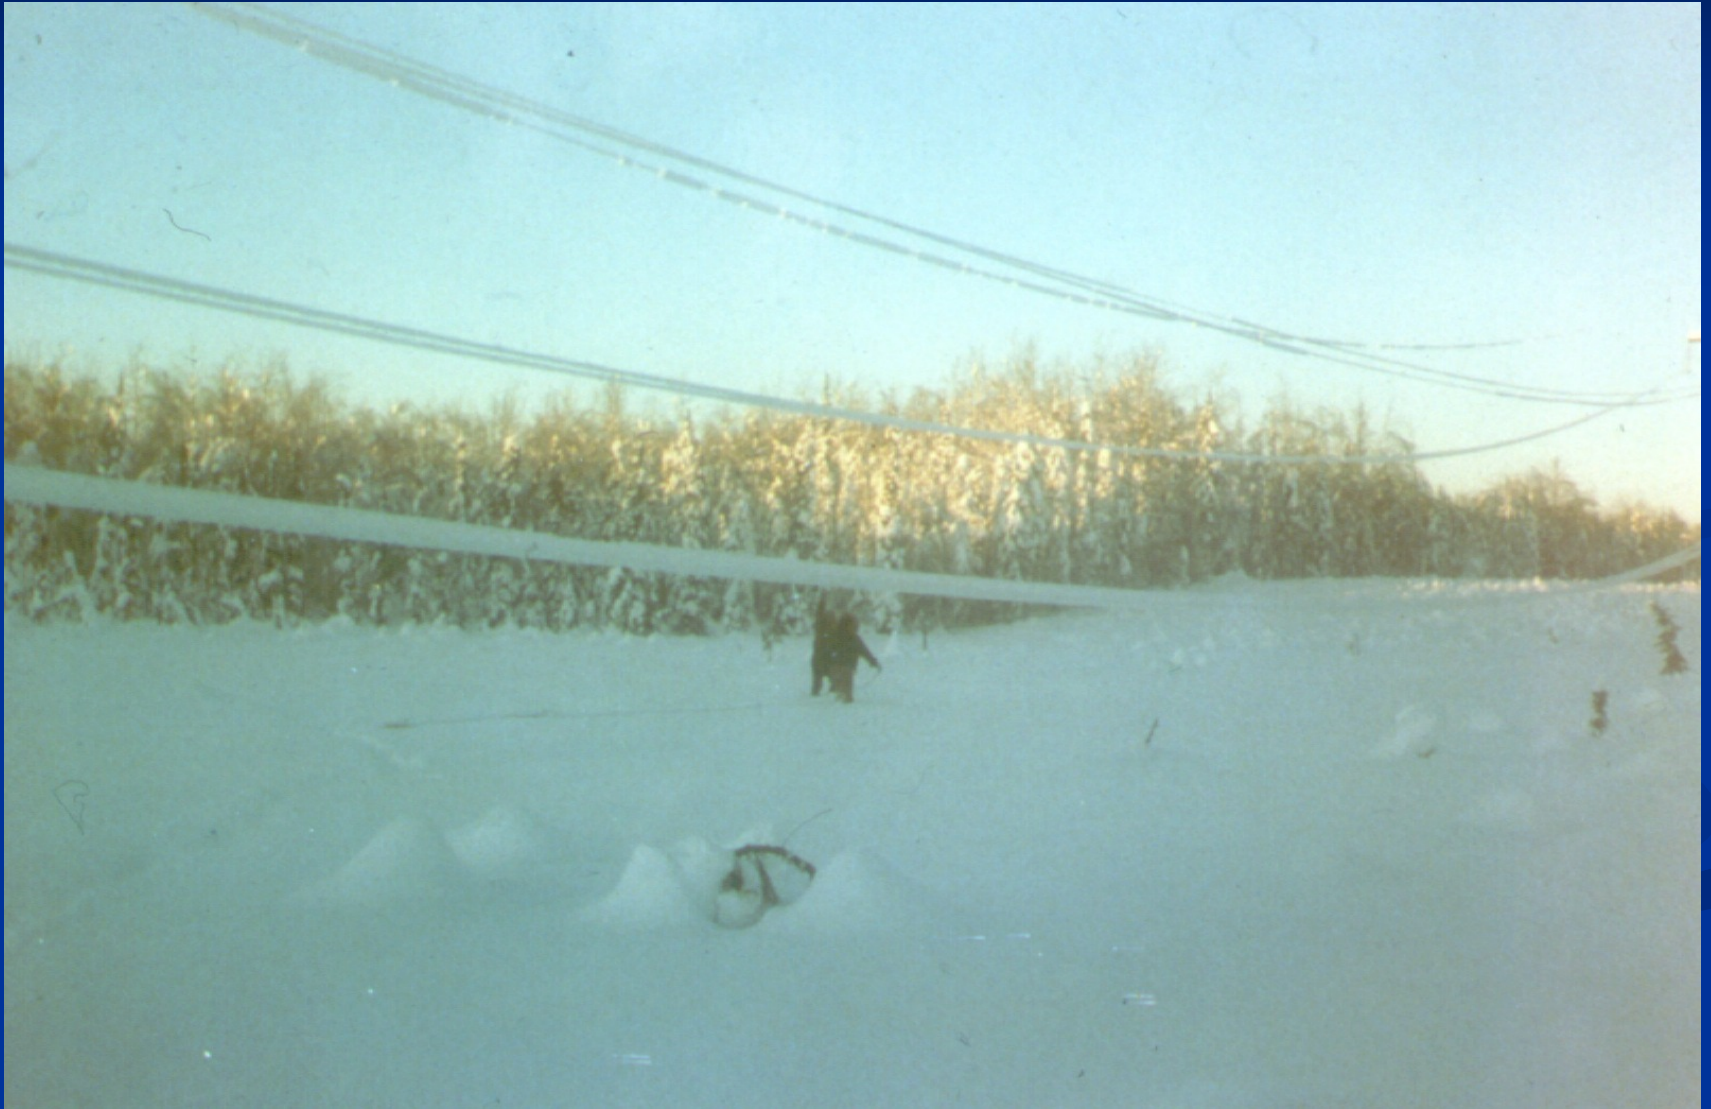
December 1990

Dec 1990

Outage Triggered Investigation Location: ???

Estimated Clearance ~7' (Estimated from Pictures)

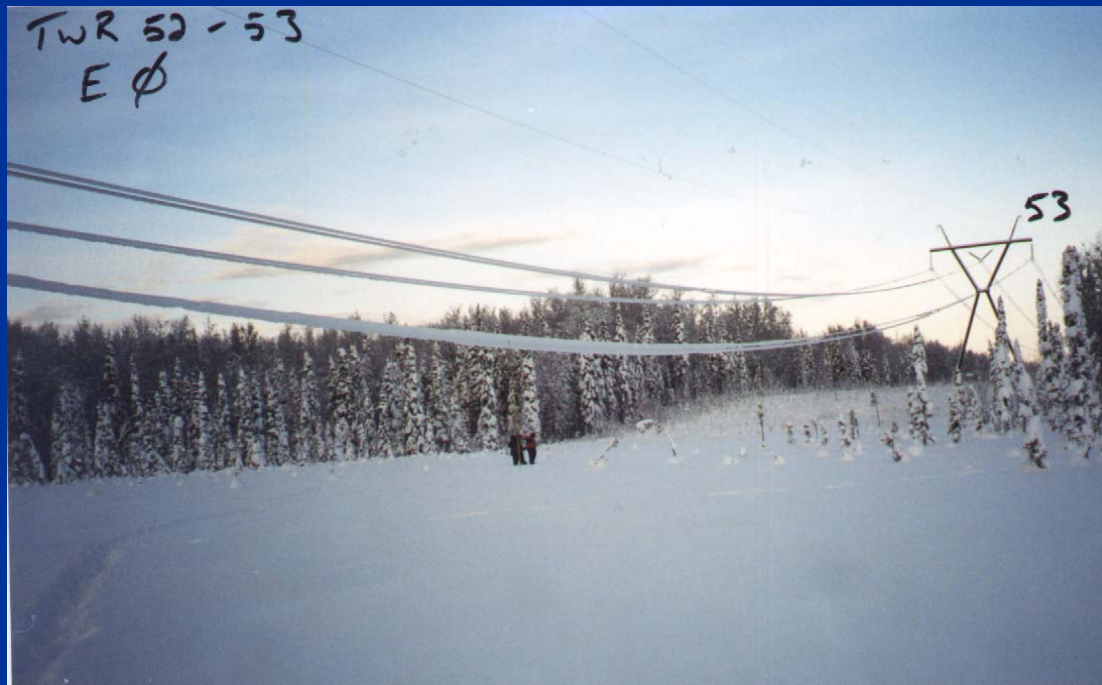
Major SLMS Events

December 1998

Structures 52-53, 96-98

Estimated Clearance:

- 18'-6", 19'-3"

Estimated Snow Diameter:

- 10-11"
