# Chugach transmission line photographic database project

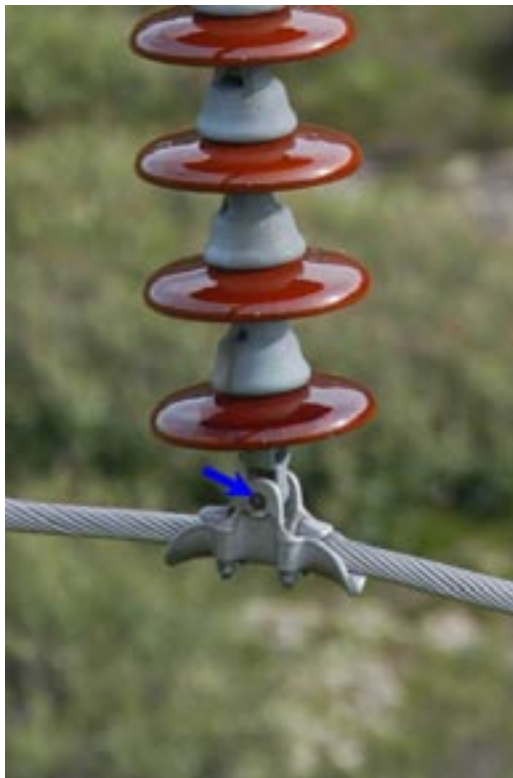
Above: The cotter pin is bent and the conductor pin has backed out to a point where it may not support the weight of the wire much longer.
